# MAINTENANCE PARTNERS

# Welcome Presentation Title

MP at Work

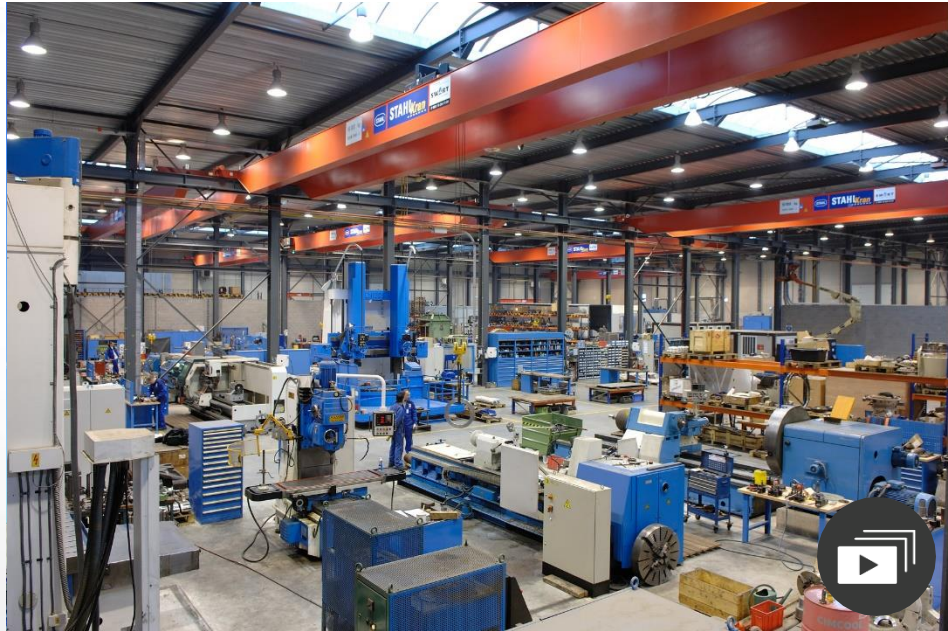
# MP Workshops

- 20 000 m<sup>2</sup> total floorspace
- Overhead cranes up to 110.000 KG
- Lathes
- Milling machines
- Horizontal bore
- Welding equipment
- Coating applications
- Climate controlled measuring room
- 3D measuring equipment
- Atos triple scan
- Material analyser
- Welding robot
- Electric test facilities
- Non and destructive test equipment
- Glass blast facilities - 8000 x 3000 x 3000 mm

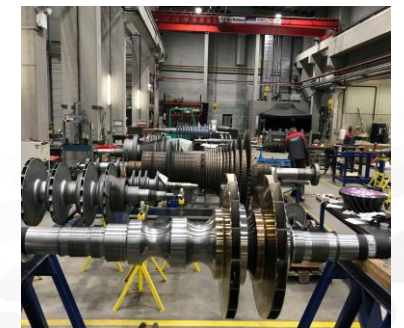
# MP Rotor shop

Max rotor weight	600 – 12.500 kg	60 – 1.250 kg

Max rotor length	6.000 mm	6.000 mm

Max rotor diameter	1.700 mm	1.700 mm
Max journal diameter	280 mm	125 mm

Max drive speed	12.000 rpm	30.000 rpm

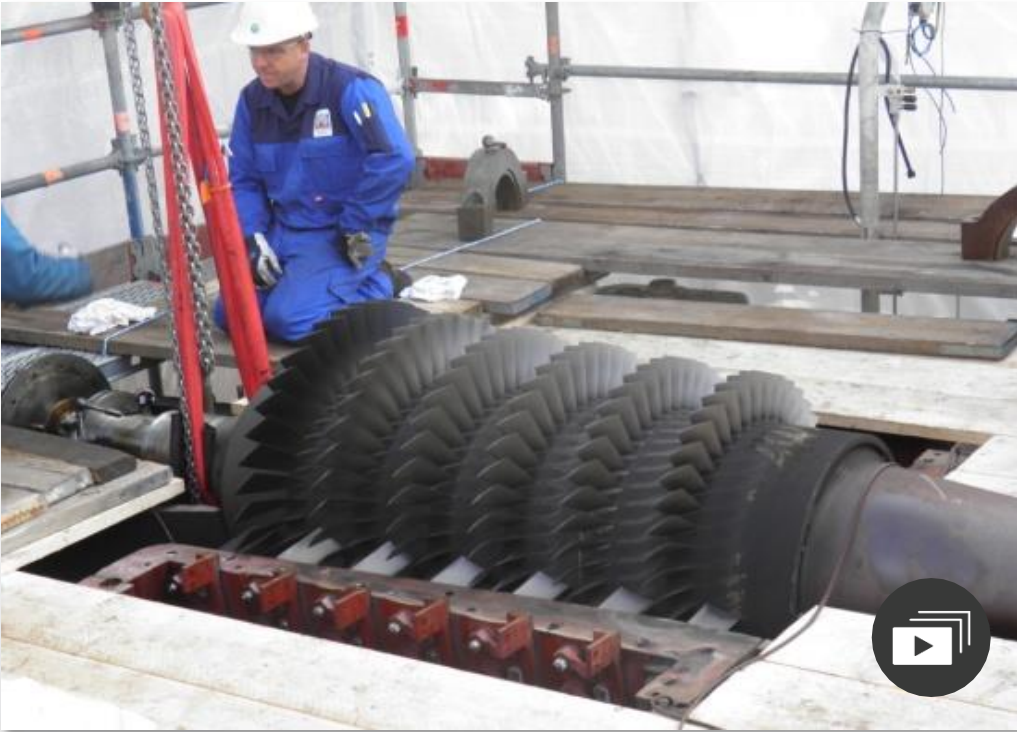
# MP Field service

Our highly skilled field service employees provide services such as minor and major overhauls, including commissioning and start-up assistance. This service can be performed on scheduled or non scheduled maintenance.

- Tool and hoisting containers
- Hytorc
- Laser alignment
- Condition monitoring
- Field balancing
- 3D scan
- Atos triple scan
- Non destructive testing

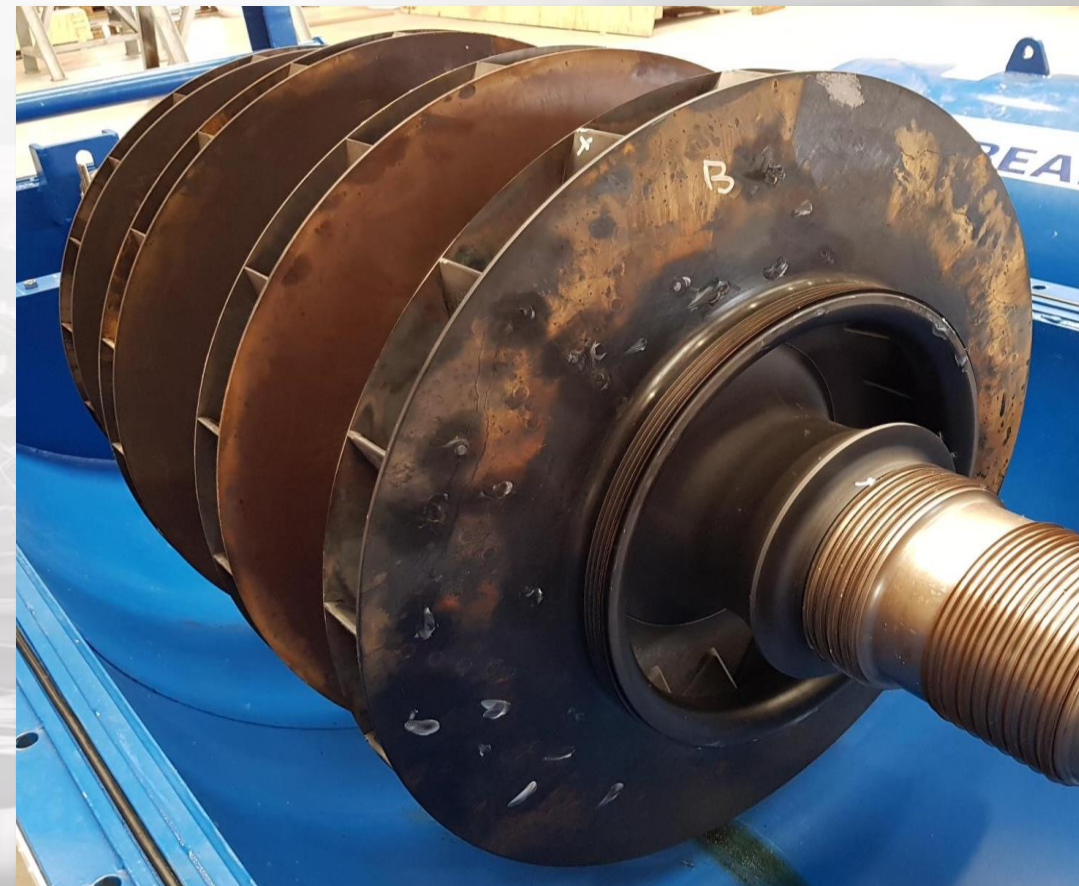
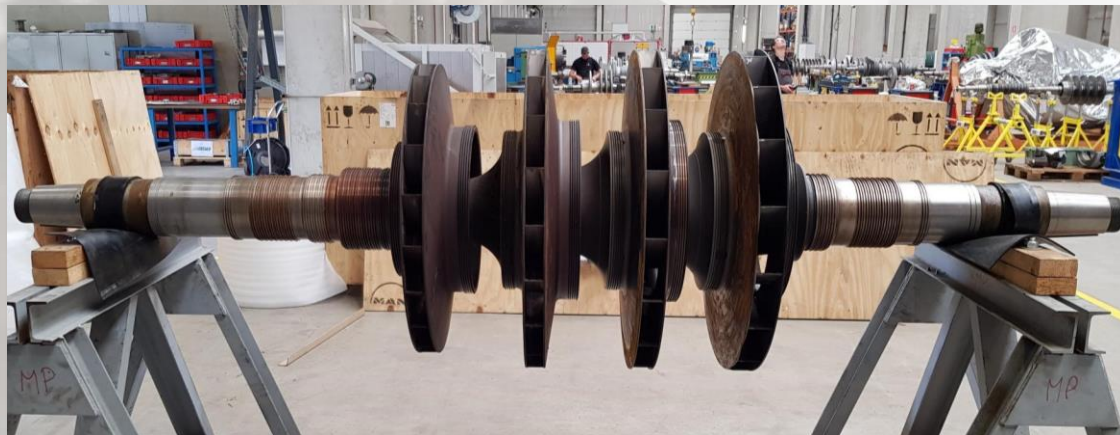
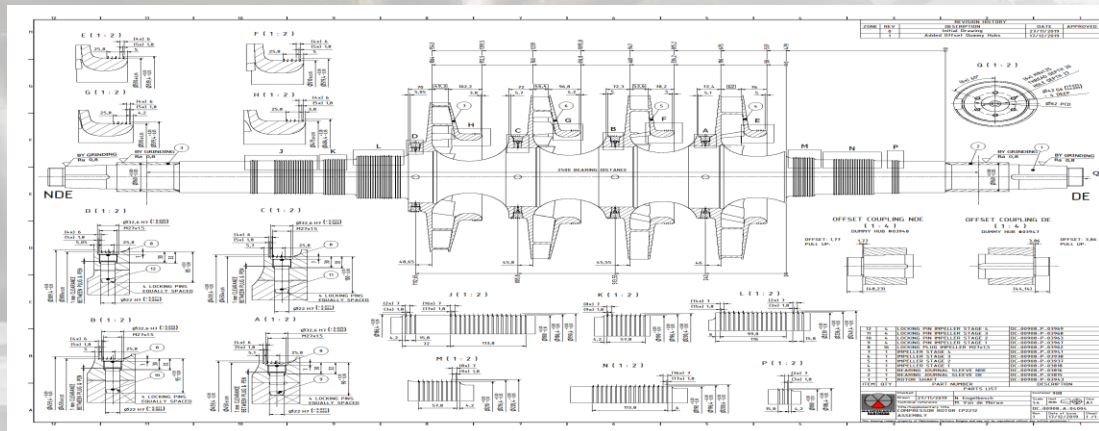
## Brand new compressor rotor

- The rotor had reached end of life and had to be renewed
- MP's engineering team scanned and re-engineered the rotor fully according to the customer's specifications → **Fit for purpose**

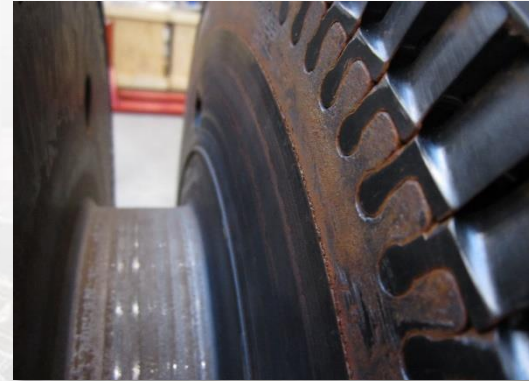
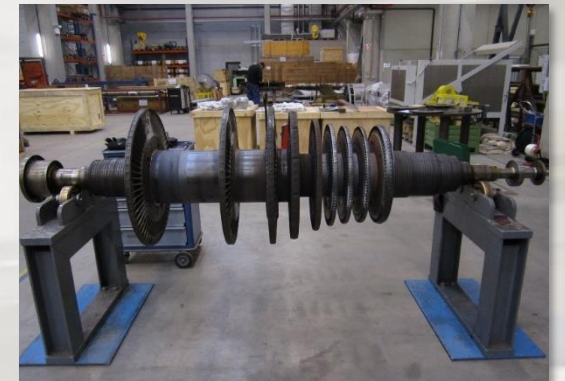
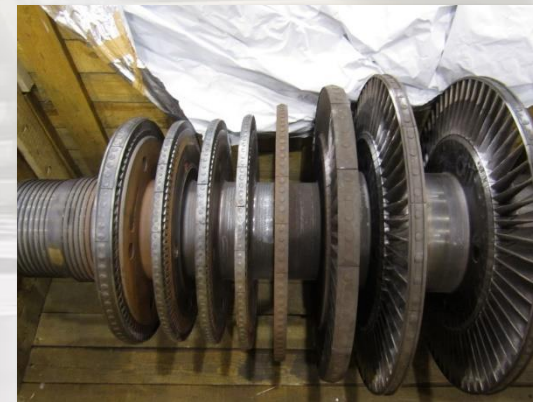
## Reverse Engineered repair of steam turbine rotor:

- After NDT inspections on the rotor NCR's were found
- Second and third row wheels were in severe condition!
  - deformation; axial bending of the wheels +/- 20 mm
  - several cracks in shroud bands and discs
- After dismantling the blades, the 2 wheels were machined off completely to the shaft, and build up again by performing robotic TIG welding technology

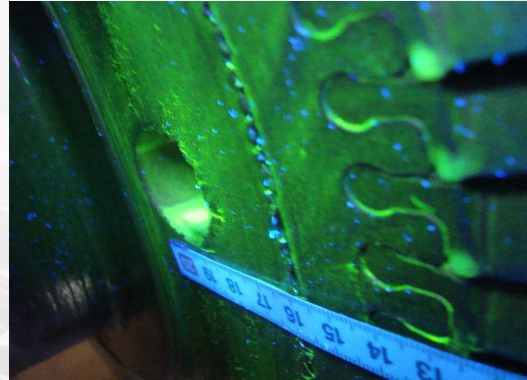
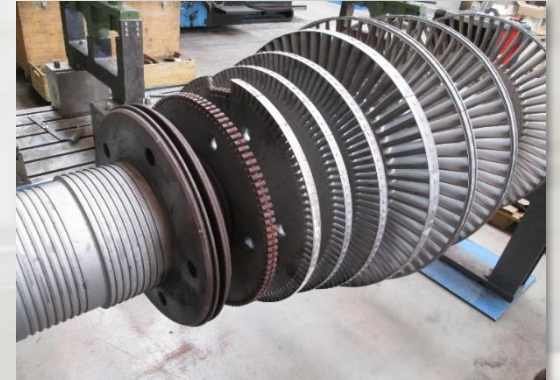
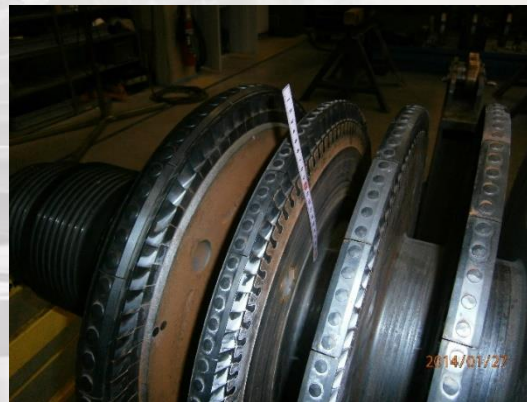
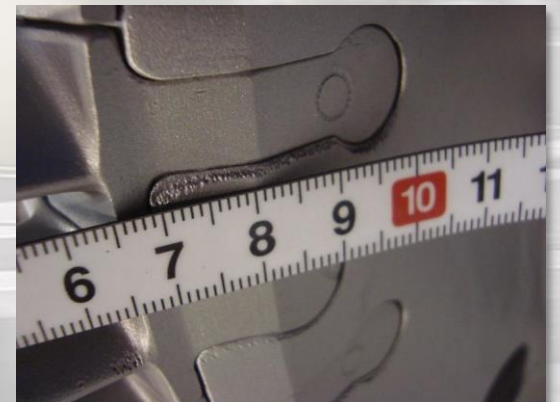
## Reverse Engineered repair of steam turbine rotor:

- Detailed analysis on the base material was done
- Composing of welding and heat treatment procedures
- Welding test was performed on sample piece

- Pre- and final machining drawings

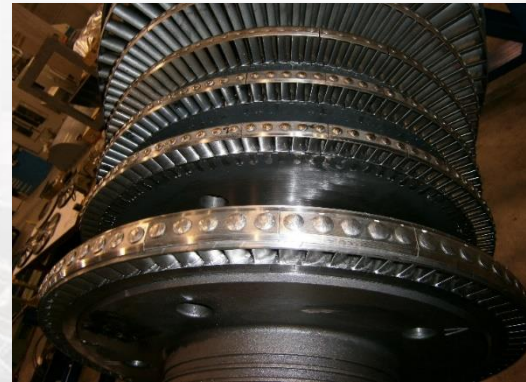
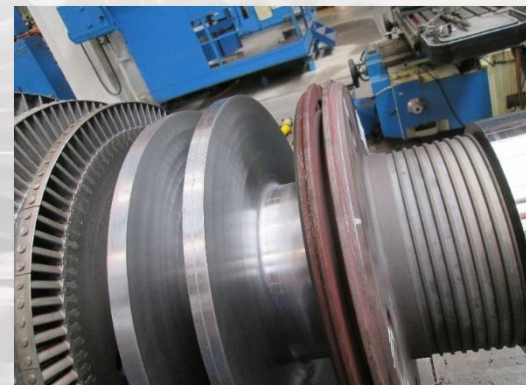
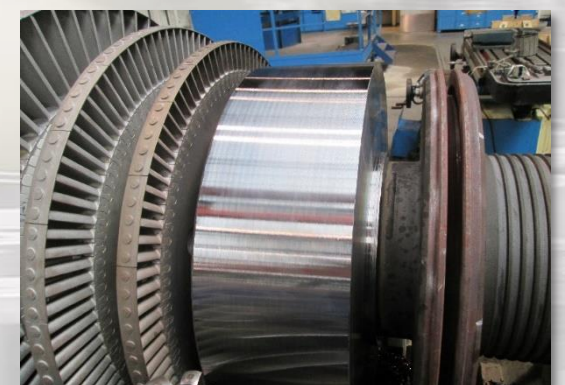
Lead-time for the welding  
repair: 8 weeks

Repair budget was a fraction  
of a new one

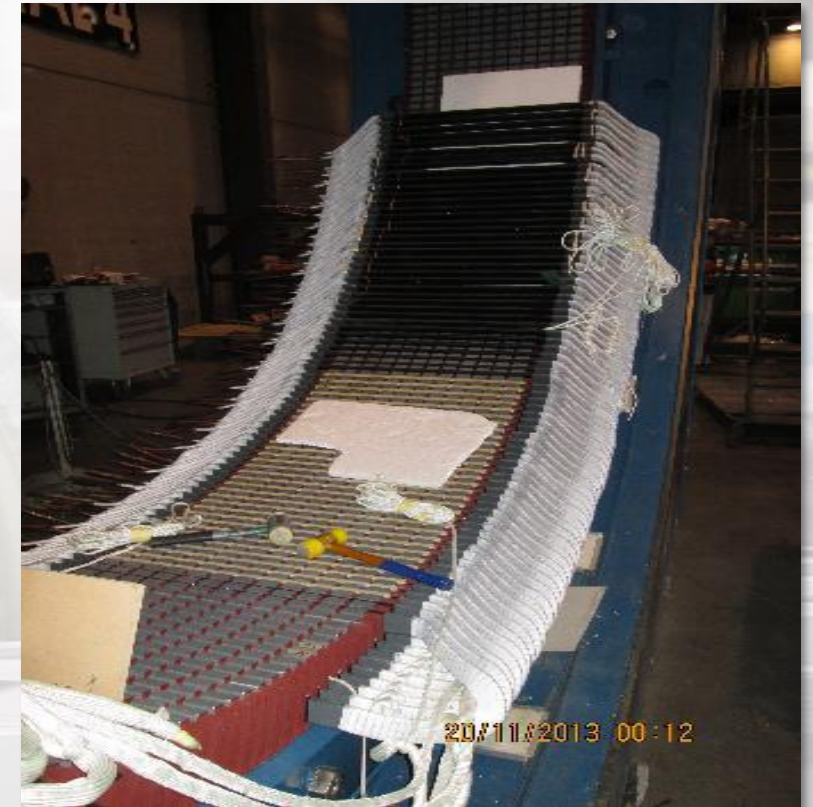
## Manufacturing of low speed compressor E-motor Stator 23MW 10KV 350 RPM

- Existing E-motor is located in an ATEX area (hazardous environment)
- Due to insulation deterioration and high level of partial discharge the installed motor is a ticking bomb!!
- Periodic follow up by on-line monitoring of the existing machine.
- On-site investigation on the existing motor 'Picture of the complete machine'
- MP copied the existing stator in order to exchange it during a planned shutdown in 2014

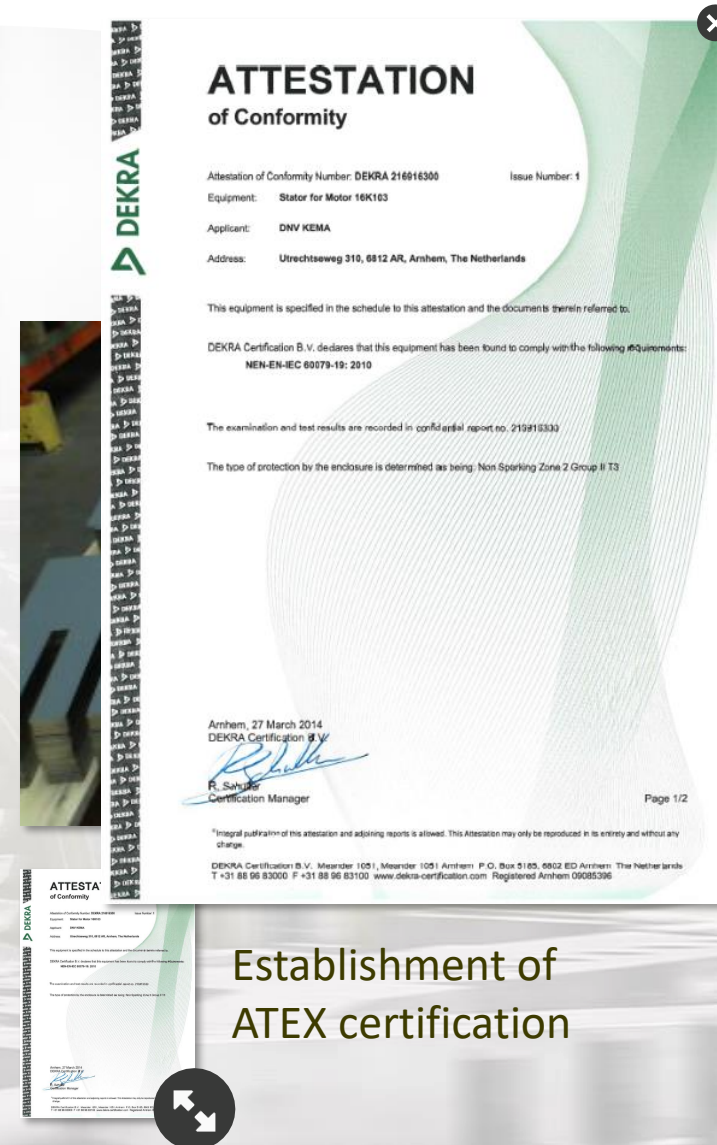
Manufacturing of low speed  
compressor E-motor  
Stator 23MW 10KV 350 RPM

- Re-engineering of the stator frame
- NDT
- Stripping of the insulation
- Dimensional check of profile copper wire
- Redesign of the coils
- Calculation of new magnetic core plates
- Less losses & higher efficiency!!
